Aesthetic Restoration of Maxillary Central Incisors.

Cathia Bergeron, DMD, MS.

Case Report

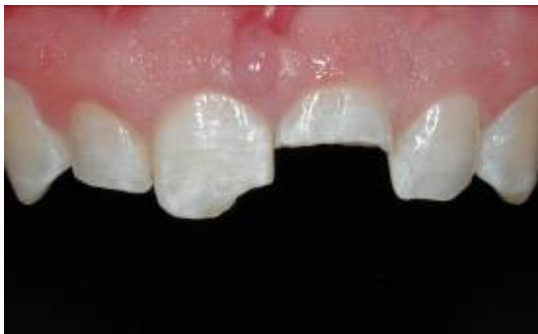
The patient, a 22-year-old male, visited the clinic after having broken teeth Nos. 1.1 and 2.1 in a fall the previous night (Figure 1). The patient's college graduation was in 3 days, and he was seeking a way to repair the teeth quickly and aesthetically. Radiographs were taken, and because of the severity of the break on tooth No. 2.1, it was also tested for vitality with an electric pulp test, a cold test, and a percussion test prior to determination of treatment. All test results showed the tooth to be vital, and the patient agreed to proceed with a resin buildup. The patient was informed at this time that tooth No. 2.1 would have to be monitored closely with regular 6-month checkups to ensure its ongoing vitality, and he understood that a root canal might eventually become necessary.

Fig. 1: The patient had broken both teeth Nos. 1.1 and 2.1 from a fall.

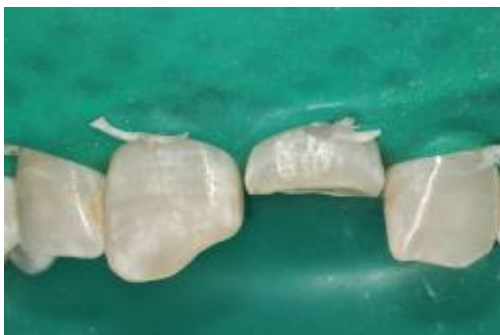
Fig. 2: The teeth were prepared with infinite bevels.

Next, a rubber dam was placed and ligated with floss. Then, the preparations were done using a flame diamond (8862-014 [Brasseler USA]) to create a bevel around the teeth. A flexible disc (3M Sof-Lex™ Extra-Thin Contouring & Polishing Disc) was then used to blend the bevel on the tooth surface and to round the sharp angles interproximally (Figure 2).

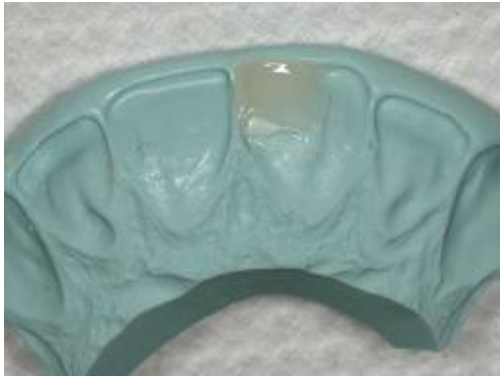
Fig. 3: A small amount of composite in shade A1E was placed in the lingual matrix.

A small amount of Filtek™ Supreme XTE Universal Restorative (3M) in shade A1E was placed in the lingual matrix (Figure 3), and the matrix was then held to the lingual of the teeth. The resin was attached to tooth No. 1.1 with a football burnisher and cured in place (Figure 4). This process created a lingual shell upon which to build the remainder of the restoration, with the proper width and height pre-determined by the diagnostic wax-up (Figure 5).

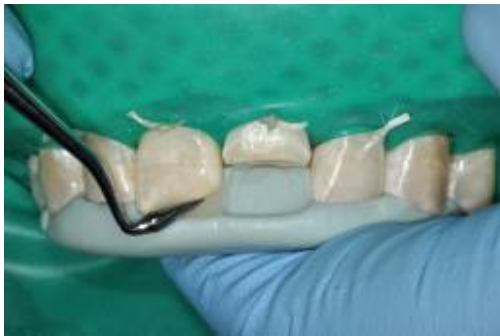
Fig. 4: A football burnisher was used to attach the resin.

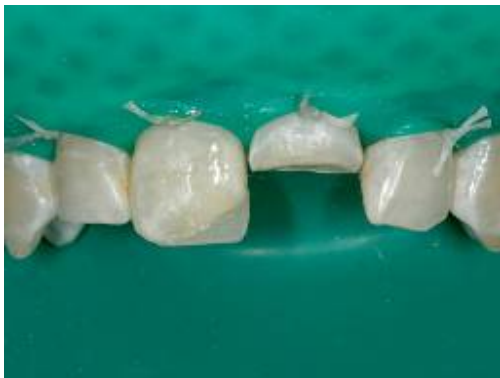
Fig. 5: The index was removed, leaving a lingual shell on which the remainder of the restoration was built.

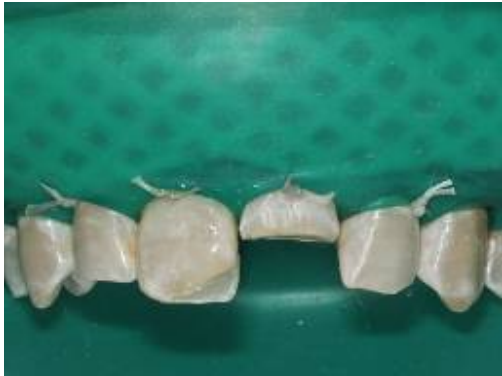
Fig. 6: A halo was created with white tint at the incisal edge.

A fine line of white tint was then applied at the incisal edge to create a “halo” on the tooth (Figure 6), and the dentin buildup was then performed with the more opaque and darker shade of Filtek™ Supreme XTE A2B shade (Figure 7). The dentin component was cured, and incisal translucent material was placed in the incisal third. These layers were followed with additional white tint to recreate the white spot effect on the patient's other teeth. The final enamel layer was placed with A1E material, and was then shaped with an interproximal carver, a gold Almore instrument, and brushes to make the surface smooth and to bring the restoration to the proper contour (Figure 8).

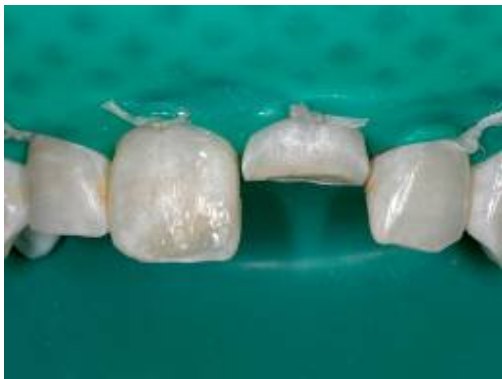
Fig. 7: Shade A2B was utilized for the dentin buildup.

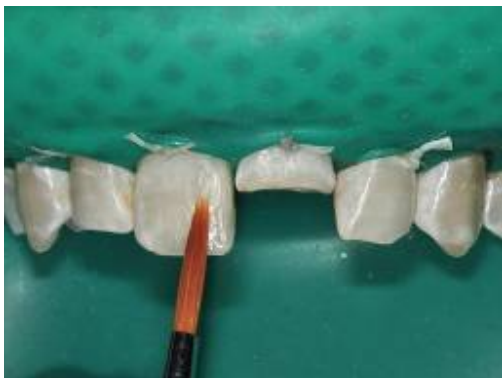
Fig. 8: The final enamel layer was shaped with an IPC, gold Almore instrument, and brushes.

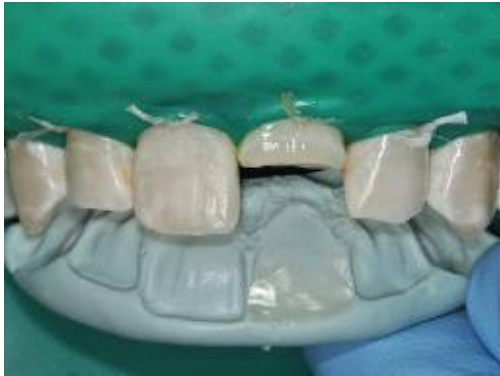
Fig. 9: Composite was placed first in the lingual matrix, then brought to the teeth and attached with a football burnisher and a brush to create the lingual shelf.

Following completion of tooth No. 1.1, tooth No. 2.1 was treated similarly. Celluloid strips were placed to protect the adjacent teeth during etching and bonding, then removed following curing of the bonding agent. Composite resin was again placed first in the lingual matrix (Figure 9), then brought to the teeth and attached with a football burnisher and a brush to create the lingual shelf. A metal matrix (Original Tofflemire® matrix band #1, .0015in. [Waterpik]) was placed and the distal contact and surface were built with A1E material (Figure 10). The same process was then used to create the mesial contact, surface and embrasure (Figure 11).

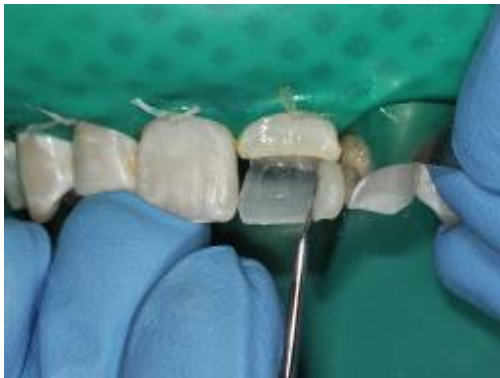
Fig. 10: The distal contact and surface were formed.

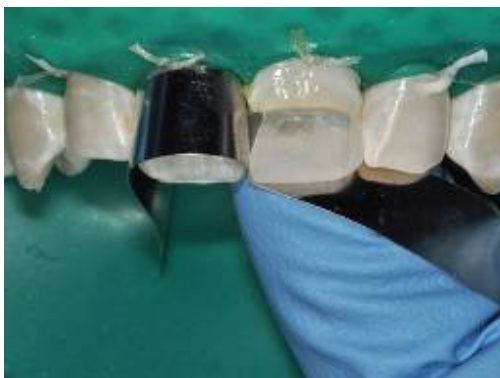
Fig. 11: The mesial contact, surface and embrasure were created.

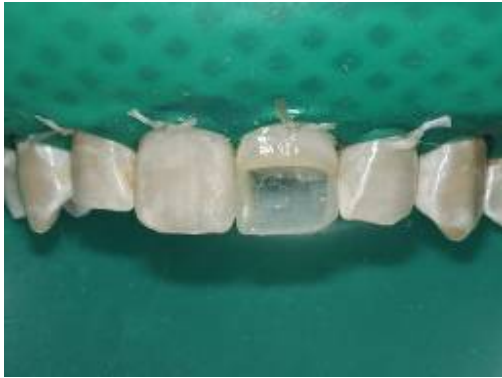
Fig. 12: The final proximal surfaces.

With the lingual, mesial and distal components in place (Figure 12), the dentin buildup was performed with Filtek™ Supreme XTE A2B material. The dentinal lobes were shaped and cured, and an incisal halo was again created using white tint. Clear translucent material was used in the incisal third between the dentinal lobes, and white tint was then

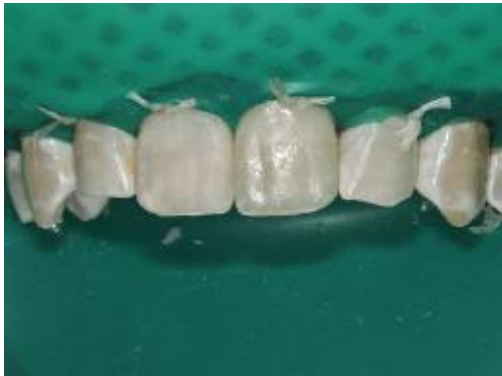
Fig. 13: Final contour of the restorations before finishing.

applied and cured. The final layer of A1E was placed and shaped as described for No. 8 (Figure 13).

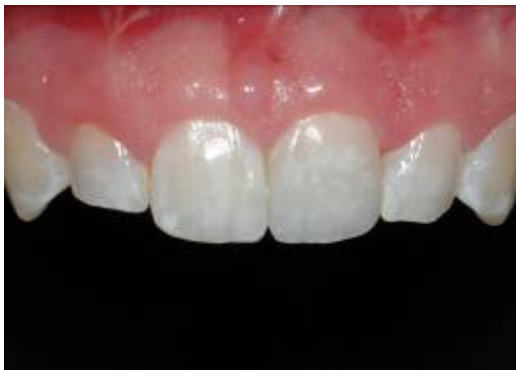
Fig. 14: The completed restorations.

The completed restorations showed a very natural emergence profile and the overall match to the patient's teeth was excellent (Figures 14 and 15). The patient was very pleased with the final result and felt confident heading in to his graduation. Despite the success of this treatment, the patient understands that the area must be monitored carefully in the future due to the trauma the teeth suffered. However, if tooth No. 2.1 remains vital, it is hoped that these restorations will serve for a number of years.

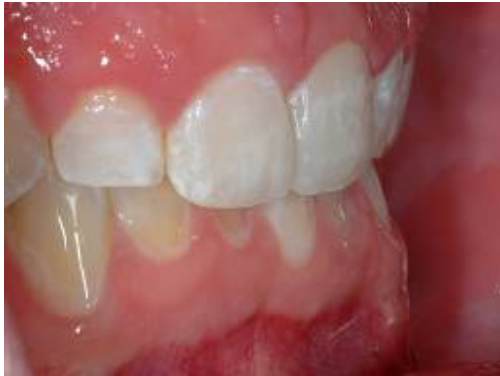
Fig. 15: A very natural emergence profile was achieved.
